**University of Connecticut Fire Department
Fire Marshal Unit
Fire Investigation - Origin and Cause Report
Page 1 of 9**

UConn FD Case/NFIRS Incident #: 23-05373

Report Title: Whitney House Structure Fire

Location of Incident: The physical address of the structure is 1315 Storrs Rd, Storrs, CT 06269. The building resides on the UConn Storrs Campus, adjacent to CT Route 195 and Mirror Lake. The building has also gone by the following names historically: Whitney House, International House, Rainbow House, and House 4.

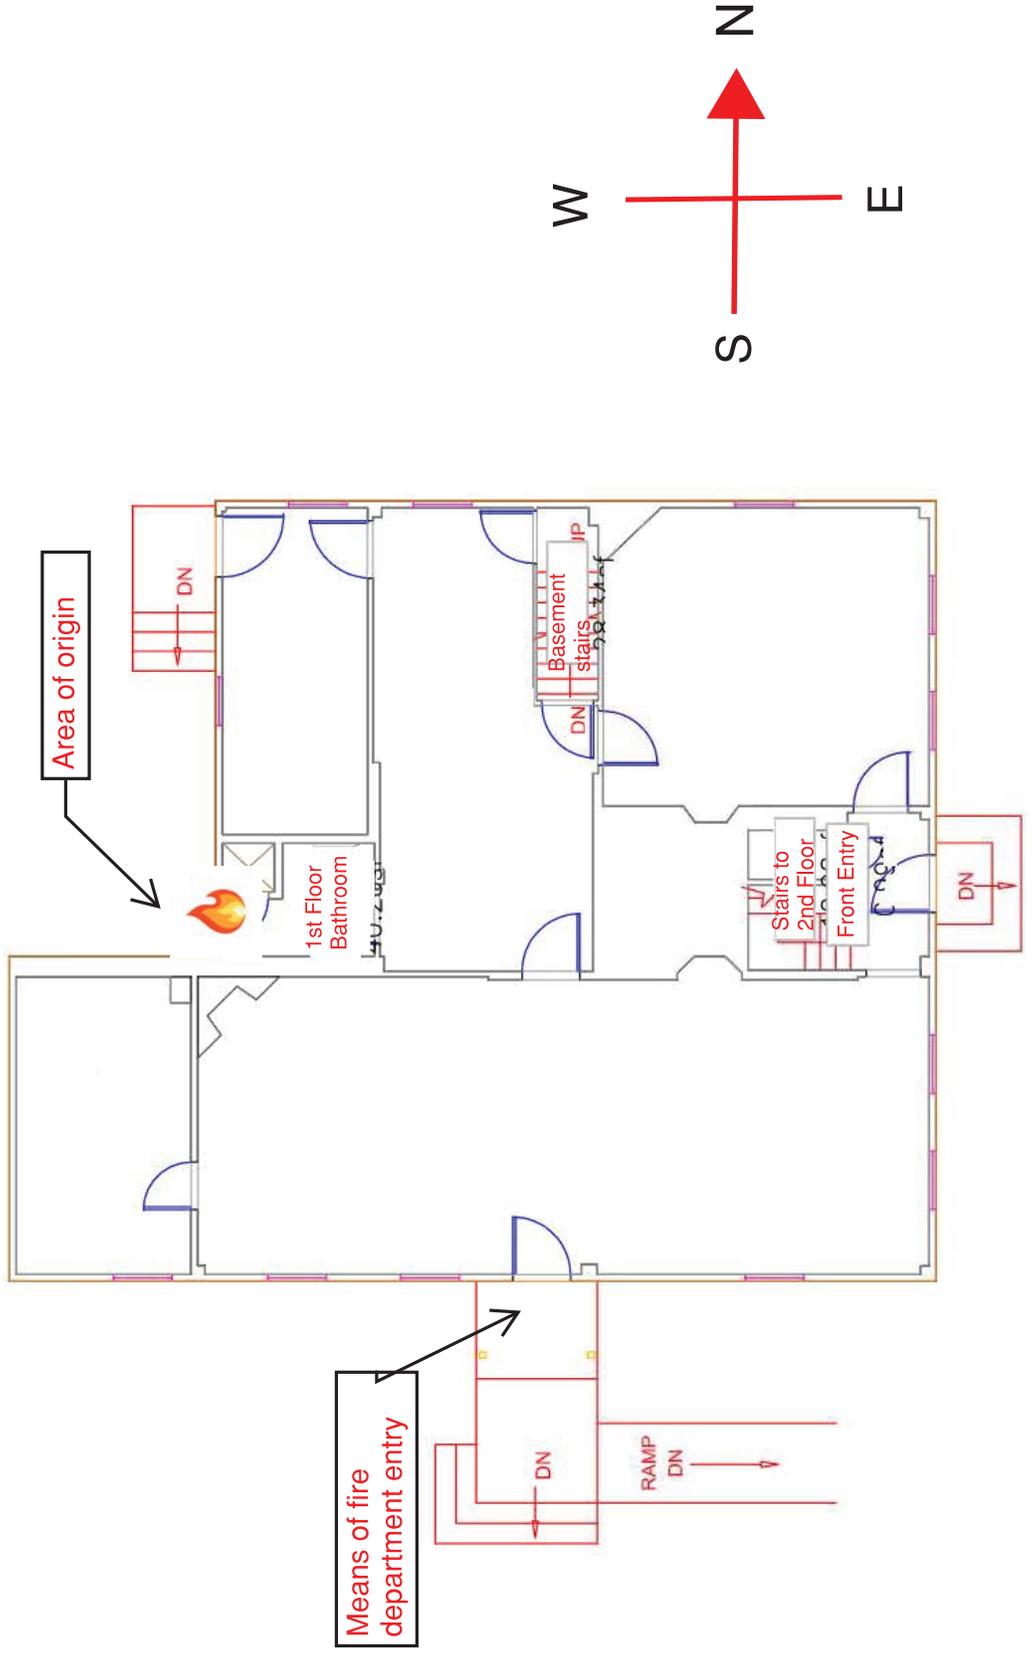
1st Floor/Area of Origin Sketch Diagram
NOT TO SCALE

Area of Origin: The area of origin was within the first floor West wall of the bathroom area, within the stud bay between the first and second floors. The exact point of origin was one of two points on the armored cable in which electrical cable failure or “blowout” occurred.

Cause: The cause of the fire was the electrical cable failure or “blowout” within the area of origin, leading to the ignition of building materials in the stud bay. The exact circumstances leading to the blowout failure cannot be further determined through the scope of this investigation, however the electrified cable provided a competent ignition source to ignite and sustain the fire.
