ENVIRONMENTAL IMPACT EVALUATION

**Mansfield Apartments Redevelopment
at the University of Connecticut**

September 2022

Environmental Impact Evaluation of Mansfield Apartments Redevelopment at the University of Connecticut

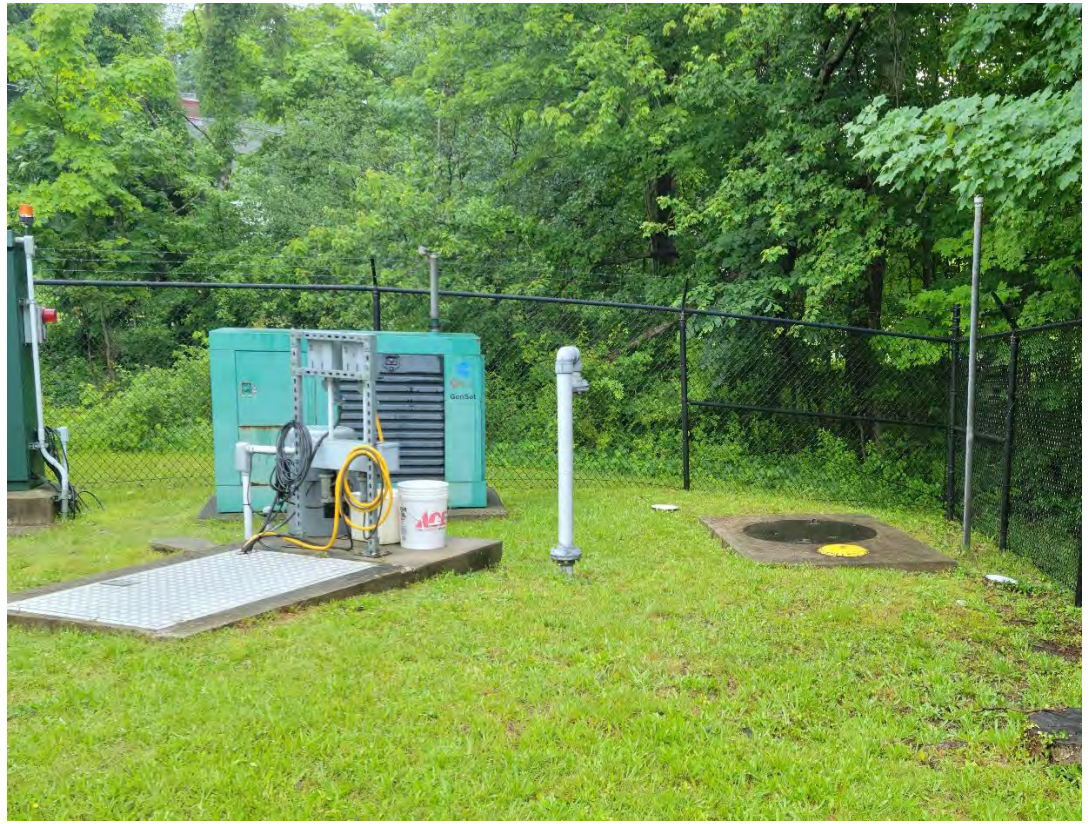
Description:
View of the emergency generator and 600-gallon underground storage tank access vault as part of the sewer pump station on the east side of the Site.

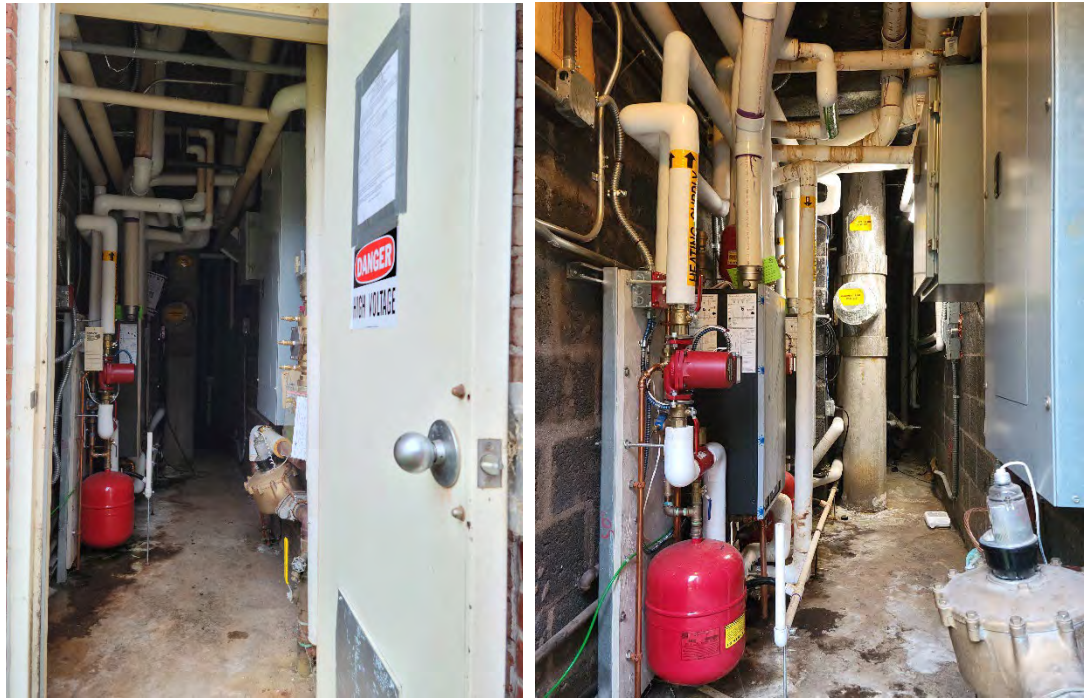
A typical interior view of the furnace closets associated with each residential building. Minor water staining on the concrete floor but no cracks or open joints observed.

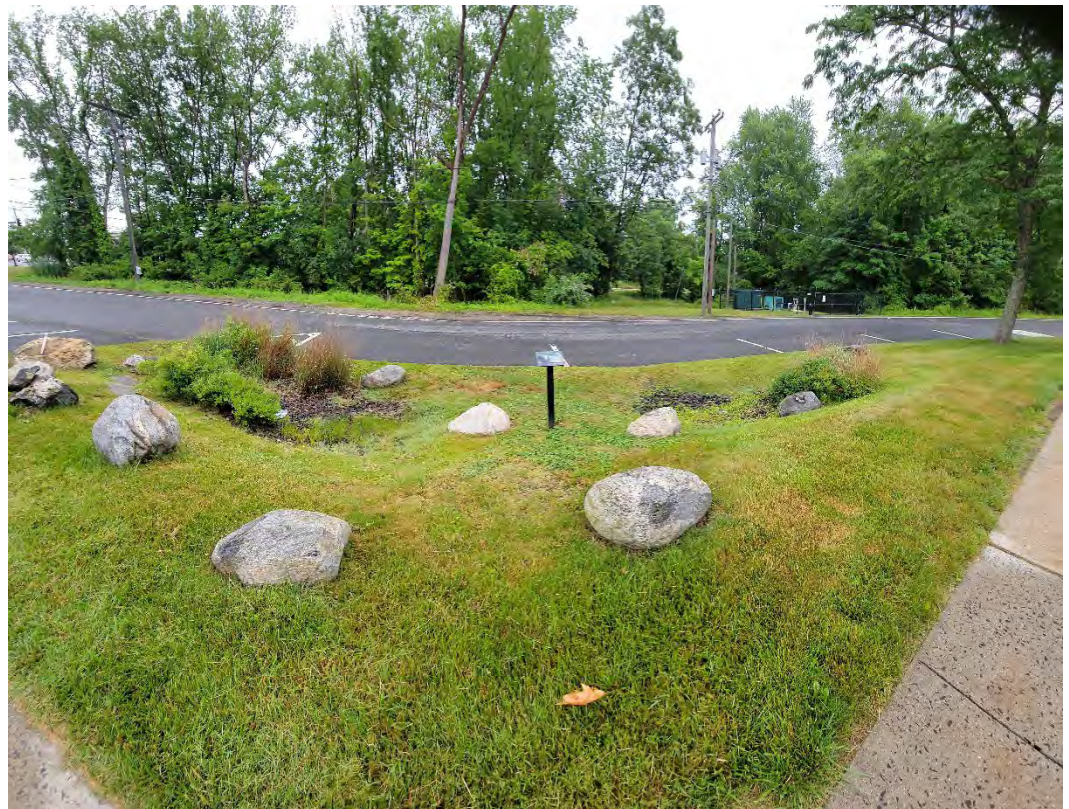
Description:
View of the bioretention ponds in the eastern portion of the Site.
